FARM MACHINERY INJURY

Power take-off shaft guards

A report for the Rural Industries Research
and Development Corporation

RIRDC Publication No 06/035
RIRDC Project No US-87A

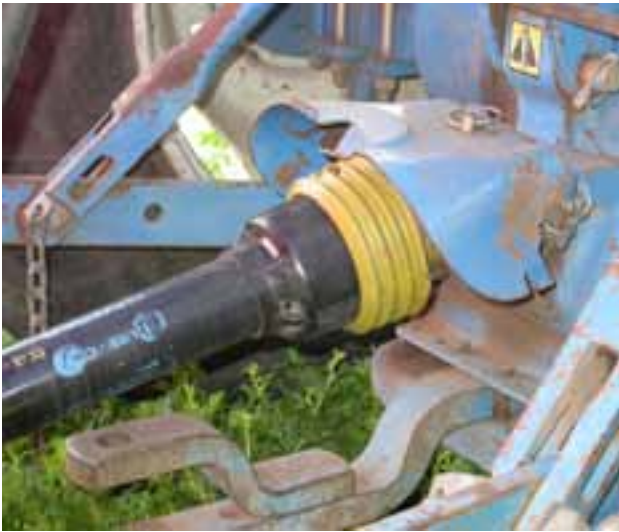
Figure 1.1 Clip-held removable Master Guard covering the connection of PTO shaft to tractor PTO.

Tractor “master guards” (Figure 1.1) cover the universal coupling joining the tractor and PTO shaft. Similar implement guards (Figure 1.2) are used to shield the coupling joining the PTO shaft to the implement, and the PTO shaft itself is enclosed in telescoping tubes to isolate it from people (Figure 1.3).

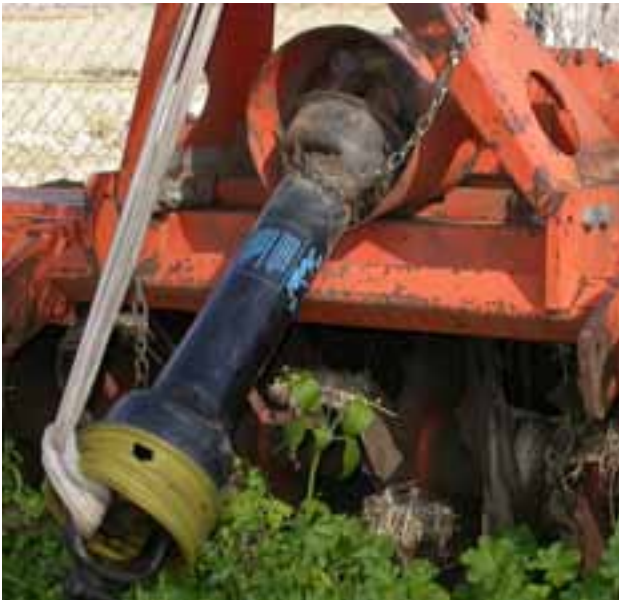
Figure 1.2 The red circular metal guard covers the universal coupling joining the PTO shaft to the implement. Note the restraining chain and method used to stop the PTO shaft from falling onto the implement.

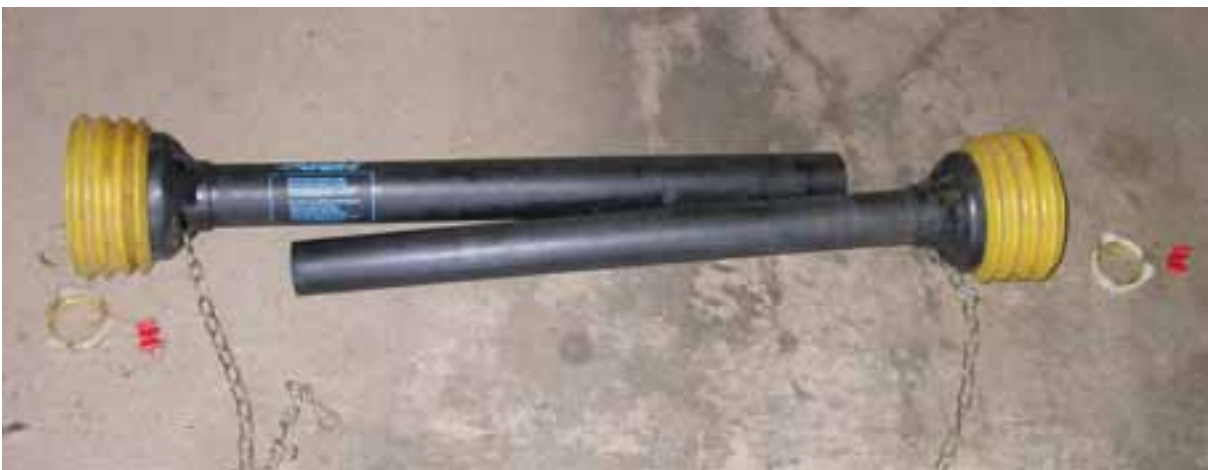
Figure 1.3: Generic PTO shield composed of : two telescoping black poly pipes or tubes, yellow bellows-like cones at each end, white nylon expandable bearings that clip into a groove on each end of the shaft, red plastic locking clips that lock the guard to the bearing, and restraining chains to stop the guard from rotating.

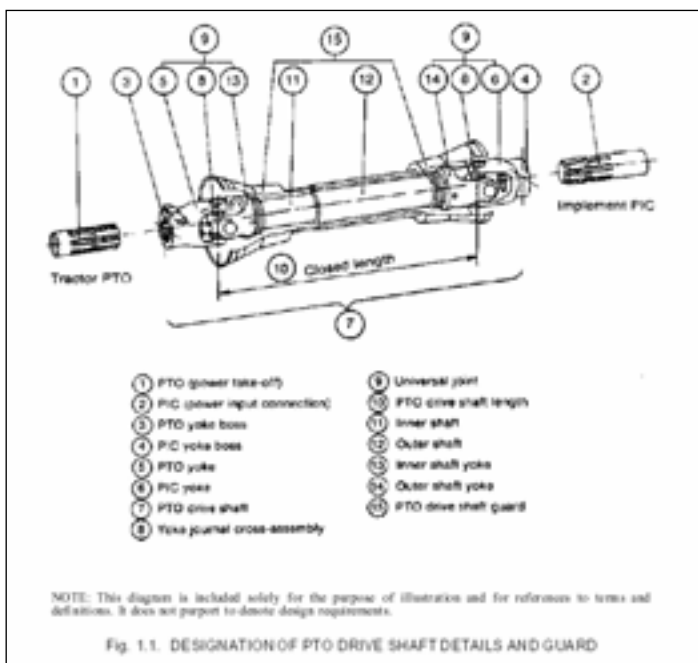
Figure 4.1: Design type of PTO drive shaft and guard to which Standard AS 1121-1983 refers

AS 1121-1998 broadly refers to a PTO guard that conforms to the design in Figure 1.1 of the Standard that is copied here as Figure 4.1.

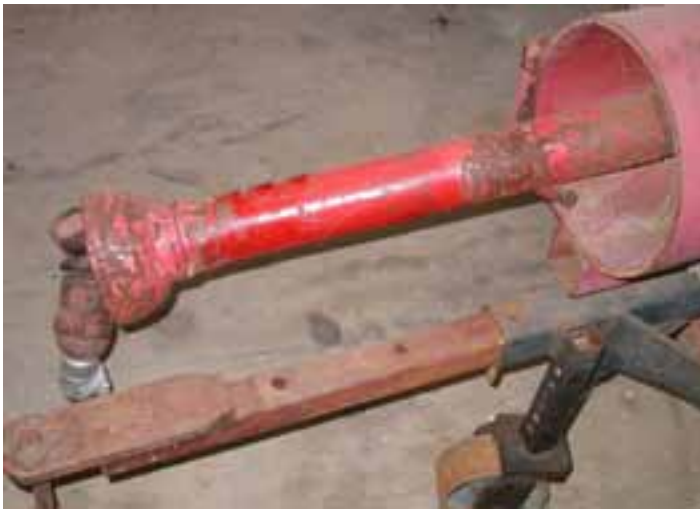
Figure 4.2: Steel PTO guard. Note resting hook to support PTO when not in use, and avoid damage by dropping onto the drawbar below.

Shields or guards to the PTO shaft have consisted of metal (Figure 4.2) or plastic (Figure 4.3) telescopic tubes over the shaft connected to conical or spherical guard cones over the couplings.

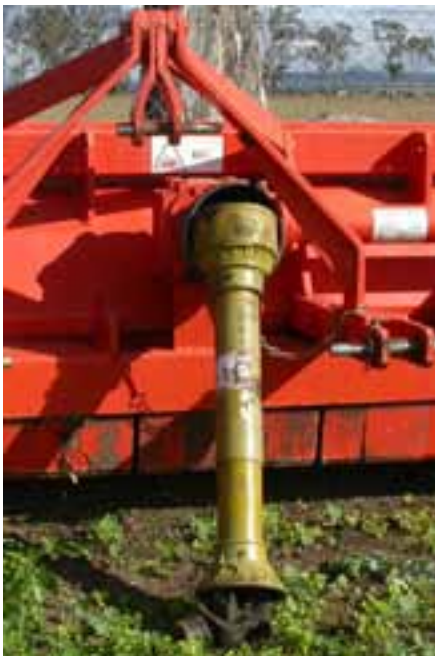
Figure 4.3: Plastic PTO shaft guard.

Polyethylene telescoping shafts (usually black to resist UV degradation) have the advantage of being very cheap, moderately flexible and capable of withstanding some physical abuse. A more flexible, usually yellow, version is used in bellows form for the cones, while bearings are normally of nylon.

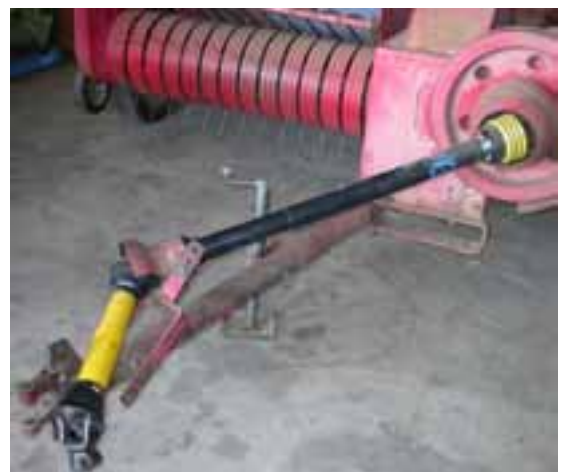
Figure 4.4: PTO transmission system for a rectangular hay baler.
